MOOLARBEN COAL PROJECT

*Traffic Impact, Road Safety
and Railway Level
Crossing Assessment*

TRAFFIC IMPACT, ROAD SAFETY AND RAILWAY LEVEL CROSSING ASSESSMENT

- Final
- August 2006

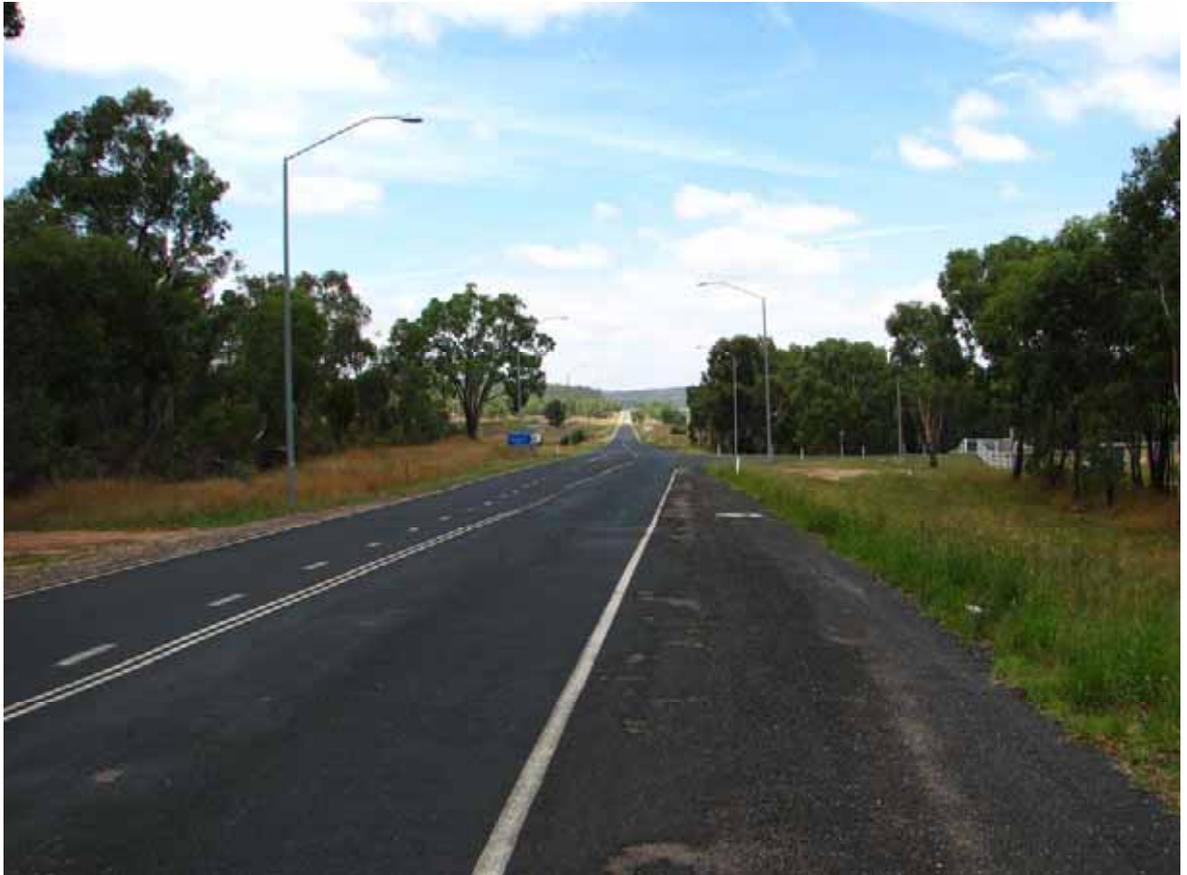
■ **Figure 3-4 Access Intersection for Ulan Coal Mine**

The type of intersection proposed would be similar to that provided as the access to the Ulan Coal Mine underground facilities off MR214 (see **Figure 3-4**), just north of the subject site. This intersection has an auxiliary lane provided to allow right turning traffic from the main road to be overtaken if required. Lighting is also provided.

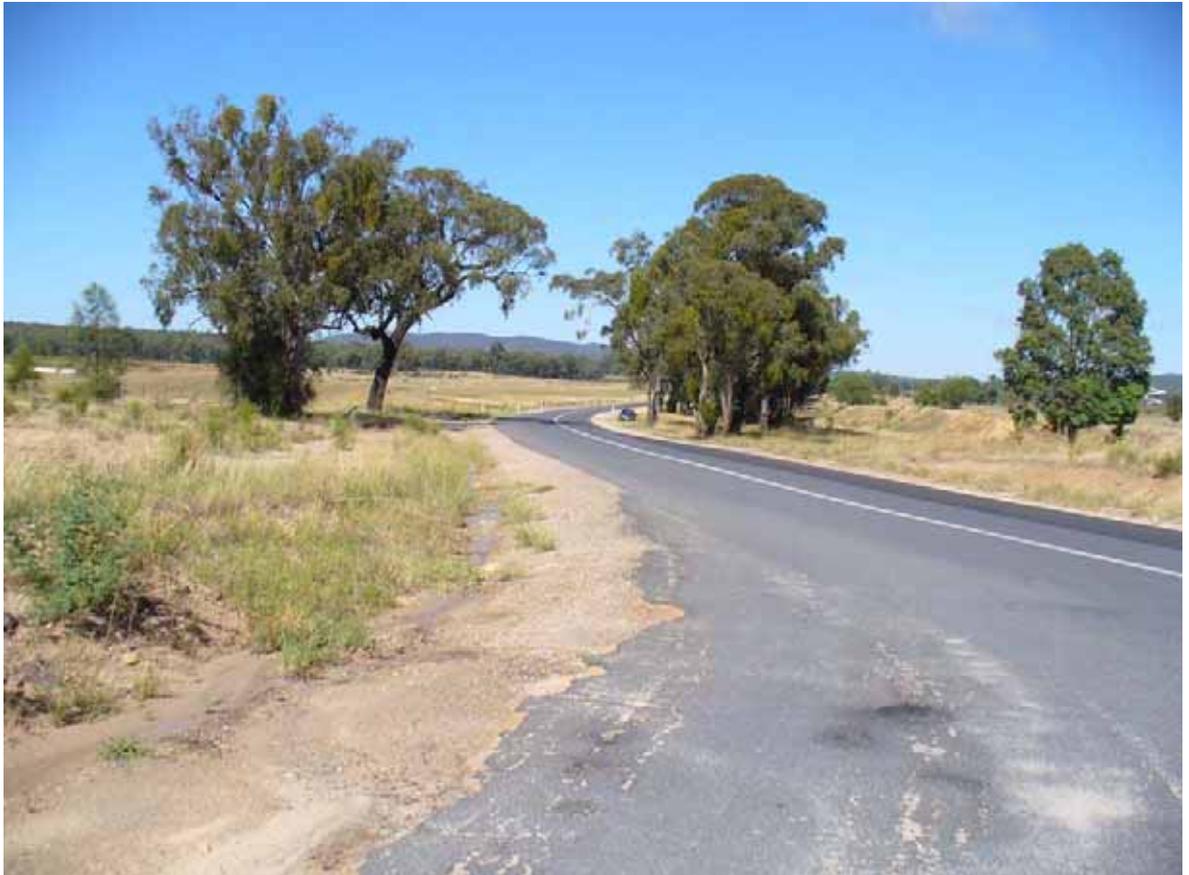
■ **Figure 4-4 Sight Distance South from Ulan-Wollar Road Intersection with MR214**

Despite the intersection having sufficient capacity, some modifications would be required to the intersection of MR214 with the Ulan-Wollar Road to improve safety. These modifications would include linemarking at the intersection to provide formal auxiliary lanes on MR214 for turning traffic, and improvement of sight distance to the south by the removal of some trees (see **Figure 4-4**).

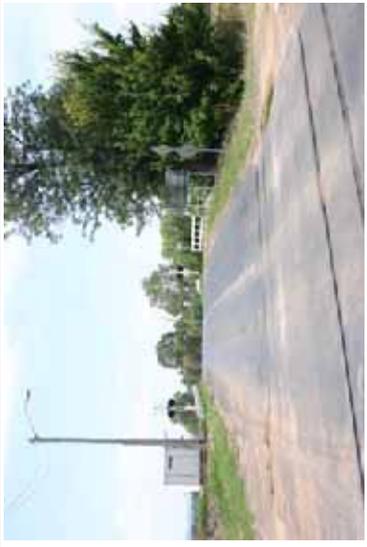
Distance from Gulgong (km)	Description	Photograph	Recommendation
0.4	Trees obstructing view up the railway line at the level crossing.

Remove trees to improve sight distance.
2.2	Although there is a warning sign on the approaches to the causeway, motorists may be unprepared for the sharp dip in the road surface.

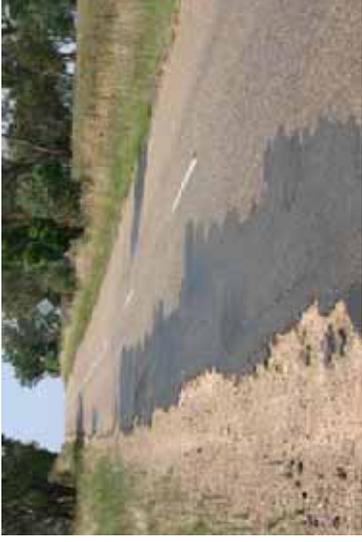
MR598: GULGONG – ULAN ROAD Direction: EASTBOUND			
Distance from Gulgong (km)	Description	Photograph	Recommendation
3.2	Cracked edges

Repair
3.6	No warning of the extent of the curve, with sight distance obstructed by trees.

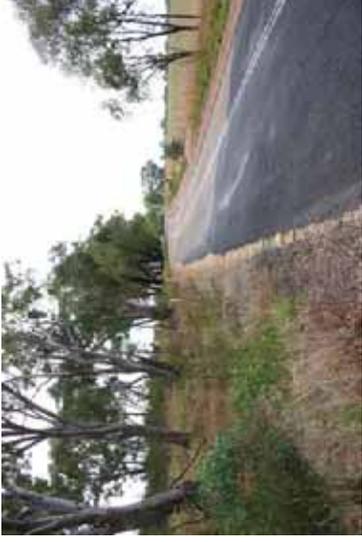
MR598: GULGONG – ULAN ROAD Direction: EASTBOUND			
Distance from Gulgong (km)	Description	Photograph	Recommendation
9.1	Poor delineation of curve at night.

Install additional guideposts along outside of curve.
9.2	Guidepost has been knocked over.

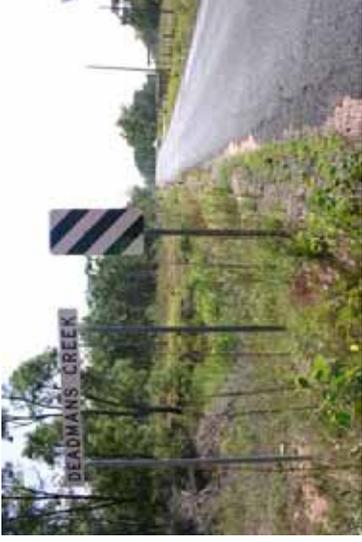
MR598: GULGONG – ULAN ROAD Direction: EASTBOUND			
Distance from Gulgong (km)	Description	Photograph	Recommendation
11.2	There is a steep drop on both sides of the road over Deadmans Creek.

Install safety barriers on both sides of the road.
22.8	The chevron signs in place (Type D4-1-1) are non-standard for this use. The chevron signs stop before curve is complete.

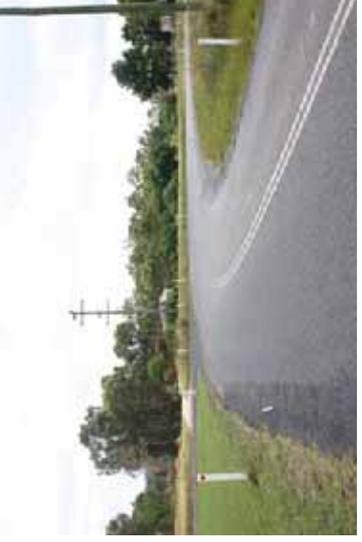
Install standard chevron alignment markers (Type D4-6) in place of existing signs, and continue around curve.
22.9	There is some confusion when making out the right-hand curve due to the road joining from the left.

Supplement the guideposts with chevron alignment markers (type D4-6).

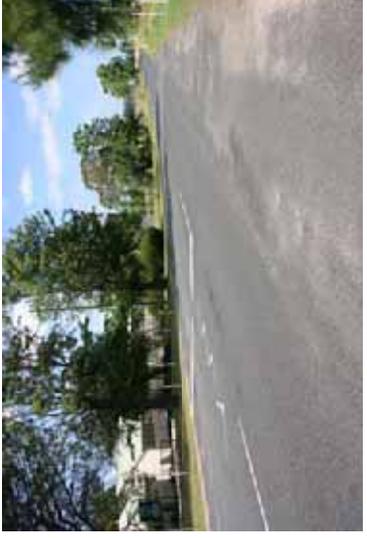
Distance from Ulan (km)	Description	Photograph	Recommendation
0.5	The school crossing outside Ulan Public School has non-standard pavement markings.

Standardise pavement markings (see AS1742, 10 and RTA Technical Direction 92/43)
9.7	There is a steep drop on both sides of the road over Deadmans Creek.

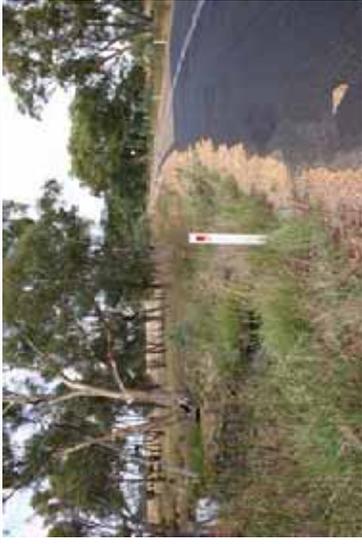
MR598: GULGONG – ULAN ROAD Direction: WESTBOUND			
Distance from Ulan (km)	Description	Photograph	Recommendation
12.8	There is a steep drop from the road to the creek.

Install safety barriers across the creek.
14.5	Cracked edges.

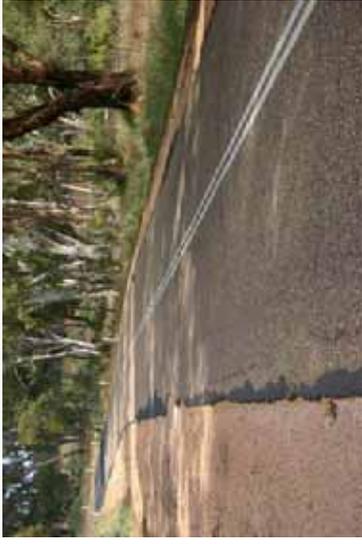
MR598: GULGONG – ULAN ROAD Direction: WESTBOUND			
Distance from Ulan (km)	Description	Photograph	Recommendation
14.5	Section of narrow carriageway. The westbound lane is only 2.5m wide (eastbound is 3.0m wide).

Widen carriageway to at least 6.0m.
14.7	Cracked edges. Section of narrow carriageway, where the westbound lane is only 2.7m wide (eastbound is 3.0m wide).

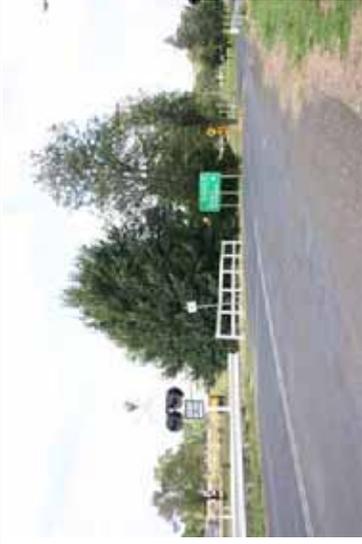
MR598: GULGONG – ULAN ROAD Direction: WESTBOUND			
Distance from Ulan (km)	Description	Photograph	Recommendation
23.5	<p>Although there are a set of railway tracks across Station Street west of the main line (running from the flour mill) they are no longer in use and the tracks do not continue on one side of the road. The existence of a railway crossing warning sign beyond the main line may mislead drivers into thinking that the main line is further west.</p>

<p>Remove signpost (and railway tracks).</p>

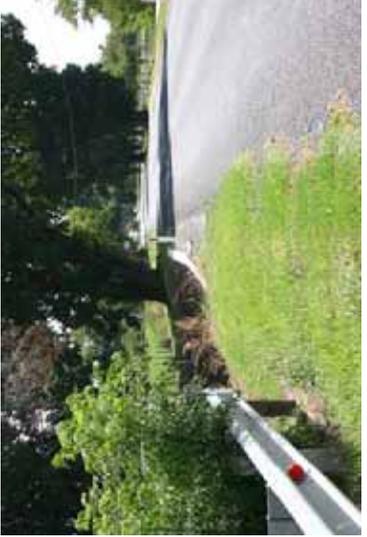
Distance from Mudgee (km)	Description	Photograph	Recommendation
0.3	Unprotected culvert just beyond the end of a safety barrier. A vehicle hitting the safety barrier may be directed into the culvert.

Extend safety barrier across culvert.
1.1	Horse warning sign obscured by tree

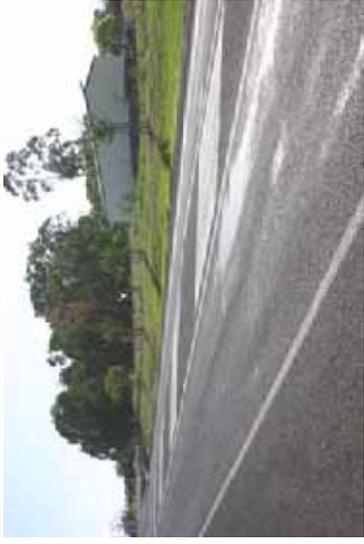
MR214: MUDGEES – ULAN ROAD Direction: NORTHBOUND			
Distance from Mudgee (km)	Description	Photograph	Recommendation
1.7	Conflicting lane markings - painted island and temporary reflective markers show different alignments (although the temporary markers are no longer reflective).

Remove temporary markers
3.0	Damaged pavement surface

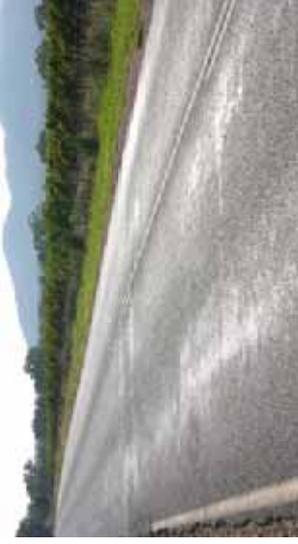
MR214: MUDGEE – ULAN ROAD Direction: NORTHBOUND			
Distance from Mudgee (km)	Description	Photograph	Recommendation
3.1	Faded centreline markings

Re-mark centre line
6.4	Non-standard lettering has been used on the "200m on right" part of this sign.

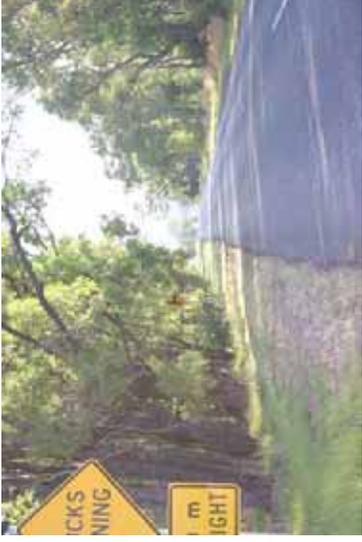
MR214: MUDGEES – ULAN ROAD Direction: NORTHBOUND			
Distance from Mudgee (km)	Description	Photograph	Recommendation
6.5	The Trucks turning sign (Type W5-22) is obscured by the tree.

Prune tree to reveal sign.
7.8	The connection between the safety barrier and bridge presents a snagging hazard.

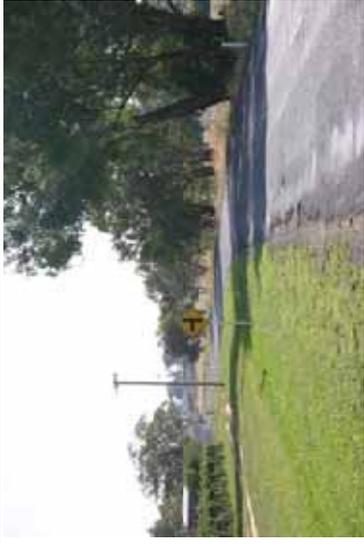
MR214: MUDGEES – ULAN ROAD Direction: NORTHBOUND			
Distance from Mudgee (km)	Description	Photograph	Recommendation
8.7	Poor delineation of the bend at night. Pavement edge cracking.

Install guide posts along bend. Repair pavement edges.
13.4 and 13.6	Fallen guidepost and tall grass obscuring the culvert.

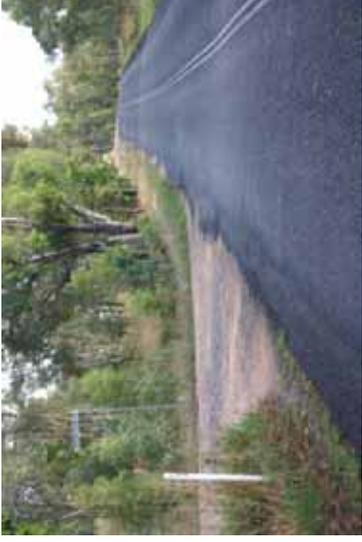
MR214: MUDGEES – ULAN ROAD Direction: NORTHBOUND			
Distance from Mudgee (km)	Description	Photograph	Recommendation
14	Steep drop adjacent to intersection which may be a hazard if a vehicle fails to make the left turn.

Seal first 10m of Spring View Road to reduce possibility of loss of traction when turning.
17.2	Pavement edges cracked

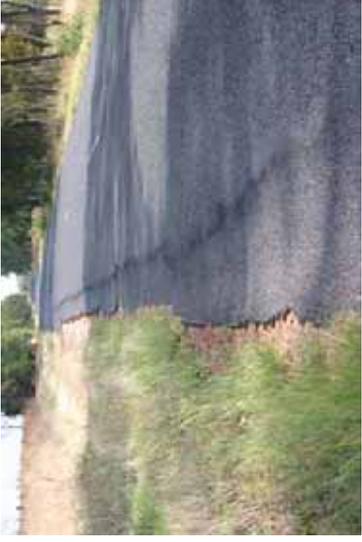
Repair edge surface
19.8	Pavement has subsided and cracked at road edge.

Repair edge surface

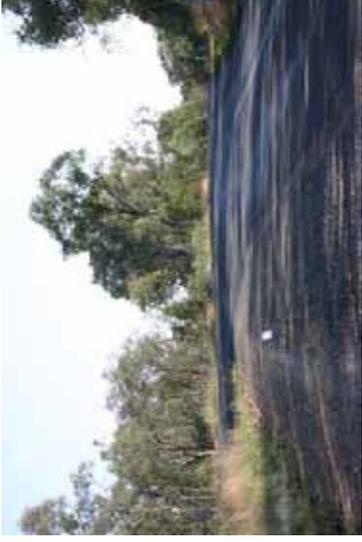
MR214: MUDGEES – ULAN ROAD Direction: NORTHBOUND			
Distance from Mudgee (km)	Description	Photograph	Recommendation
20.6	<p>The bend in the road at Mud Hut Creek Rd is on a crest, and is not obvious, particularly at night.</p> <p>A guidepost has been knocked over just south of the intersection.</p>

<p>Install chevron marker on far side of intersection.</p> <p>Relocate fallen guidepost further south to avoid being hit again.</p>
22.3	<p>Although this exposed culvert is on a long straight stretch of road, it is a convenient over-taking opportunity and overtaking vehicles may lose control when passing at speed.</p>

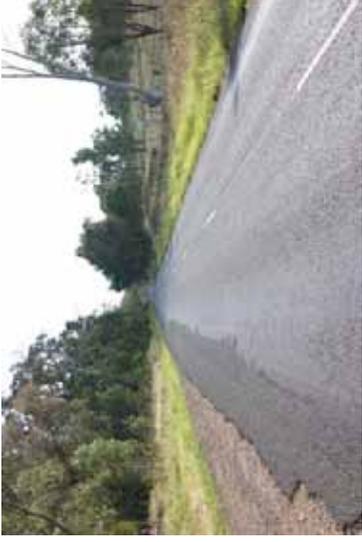
MR214: MUDGEES – ULAN ROAD Direction: NORTHBOUND			
Distance from Mudgee (km)	Description	Photograph	Recommendation
26.2	Northbound lane is wider than southbound lane – total of 4m from pavement edge to centreline on NB lane and 3 m lane width on SB lane.

Widen southbound lane to a similar width as the northbound lane. OR Relocate centre line to more evenly divide the road, taking care to totally remove any obsolete pavement markings.
26.4	There is a steep drop and many tree hazards on both sides of the road.

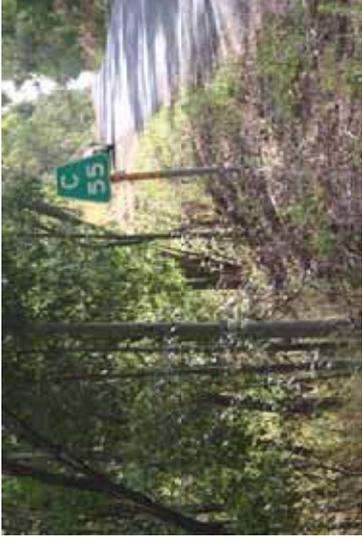
26.7 to 28.1	<p>NOT AUDITED DUE TO ONGOING ROADWORKS</p>		
28.6	<p>Signs at the Moolarben Road intersection are faded and non reflective, and may lead to vehicles slowing or stopping unnecessarily to read them.</p>

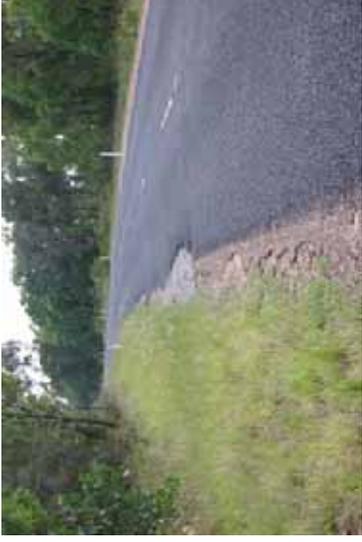
MR214: MUDGEES – ULAN ROAD Direction: NORTHBOUND			
Distance from Mudgee (km)	Description	Photograph	Recommendation
34.5	Cracked edges.

Repair edge surface.
36.9	Damaged surface.

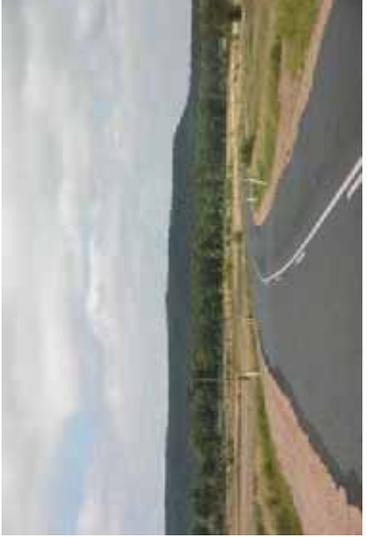
Distance from Ulan (km)	Description	Photograph	Recommendation
0.1	There is poor night-time delineation of the curve between the railway bridge and the Ulan-Wollar Road.

Install chevron alignment markers (Type D4-6).
5.1	Damaged edges.

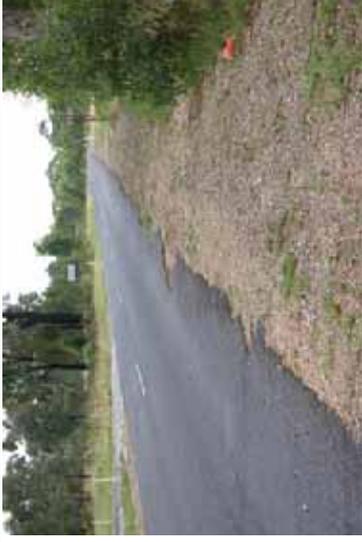
MR214: MUDGEES – ULAN ROAD Direction: SOUTHBOUND			
Distance from Ulan (km)	Description	Photograph	Recommendation
7.7	Cracked edges along SB lane.

Repair edges.
7.8	Pot hole.

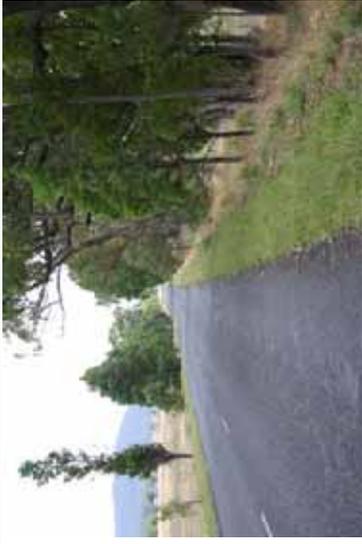
MR214: MUDGEES – ULAN ROAD Direction: SOUTHBOUND			
Distance from Ulan (km)	Description	Photograph	Recommendation
11.1	Steep drop off beside the SB pavement.

Install guideposts along the road edge.
11.3	'Intersection ahead' sign board missing from post on approach to Nimoola Lane.

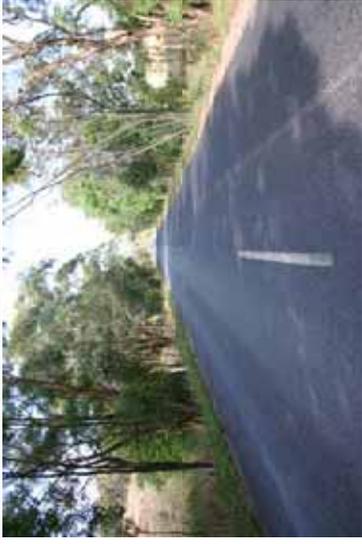
MR214: MUDGEES – ULAN ROAD Direction: SOUTHBOUND			
Distance from Ulan (km)	Description	Photograph	Recommendation
15.3	There is a steep drop and many tree hazards on both sides of the road.

Improve delineation by installing guideposts. Provide advance warning by installing D4-3 type width marking signs.
17.5	The Road Narrows sign (Type W4-3) has been knocked over.

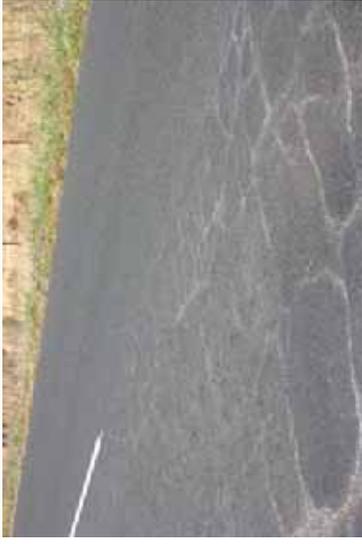
MR214: MUDGEES – ULAN ROAD Direction: SOUTHBOUND			
Distance from Ulan (km)	Description	Photograph	Recommendation
19. 7	Cracked surface along middle of road

Repair pavement surface

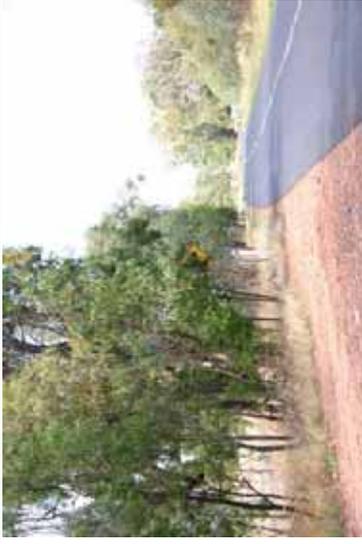
MR214: MUDGEES – ULAN ROAD Direction: SOUTHBOUND			
Distance from Ulan (km)	Description	Photograph	Recommendation
26.0	Road sign obscured by vegetation

Prune vegetation.
34.1	The connection between the safety barrier and bridge presents a snagging hazard.

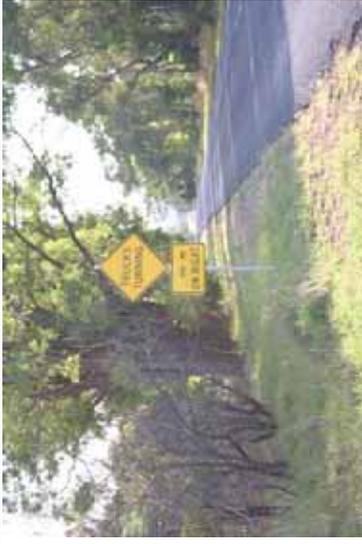
MR214: MUDGEES – ULAN ROAD Direction: SOUTHBOUND			
Distance from Ulan (km)	Description	Photograph	Recommendation
35.1	Non-standard lettering has been used on the "200m on right" part of this sign.

Use standard lettering on sign.
36.2	Intersection approach sign (Type W2-4) obscured by tree.

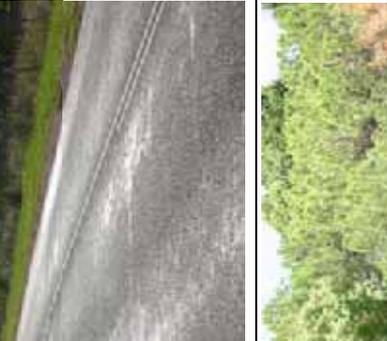
MR214: MUDGEES – ULAN ROAD Direction: SOUTHBOUND			
Distance from Ulan (km)	Description	Photograph	Recommendation
38.9	Faded centreline alongside airport.

Repaint centreline.
40.7 to 40.9	No centre line marked where the road narrows through an avenue of trees.

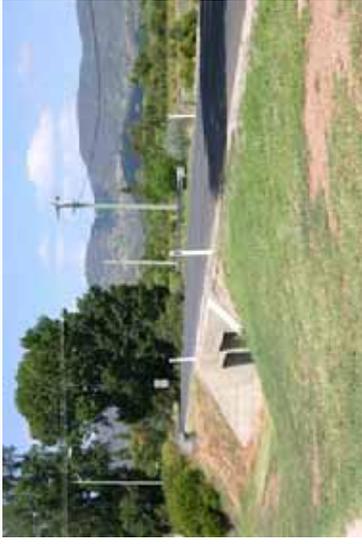
MR214: MUDGEES – ULAN ROAD Direction: SOUTHBOUND			
Distance from Ulan (km)	Description	Photograph	Recommendation
41.5	No protection for deep culvert

Extend safety barrier back from bridge to protect from culvert.
41.7	No separator of pedestrians and vehicles on approach to the bridge.

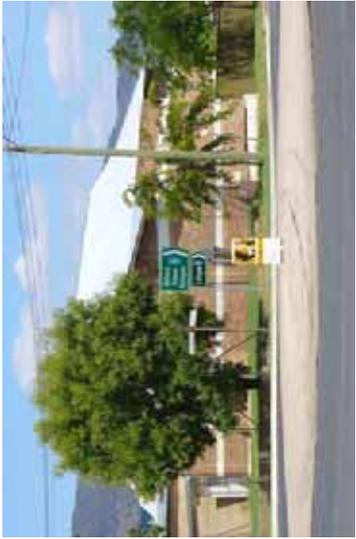
MR214: MUDGEES – ULAN ROAD Direction: SOUTHBOUND			
Distance from Ulan (km)	Description	Photograph	Recommendation
42	Markings on the roundabout at Church Street / Short Street are wearing away.

Repair signage at the roundabout.

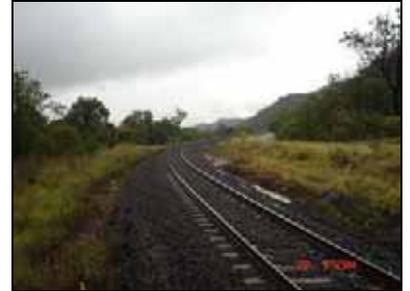
Down

Rail Sighting Up End Poor

Road Sighting Upside Medium

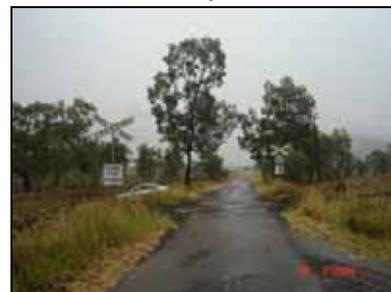
Up Side Approach

Stop signs missing on Sandy Hollow side

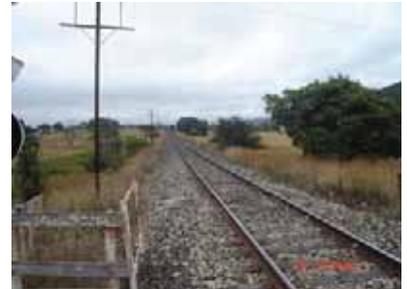
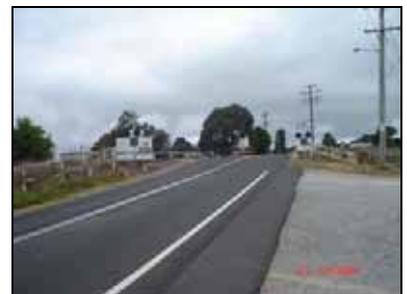
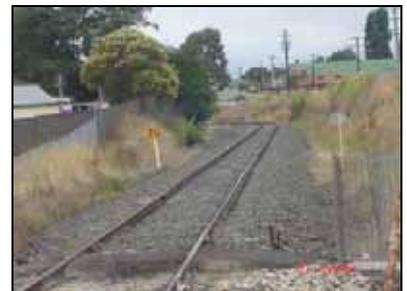
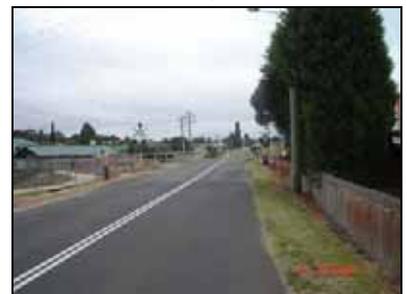
Pedestrian crossing adjacent with very poor tarmac surface and inadequate signage

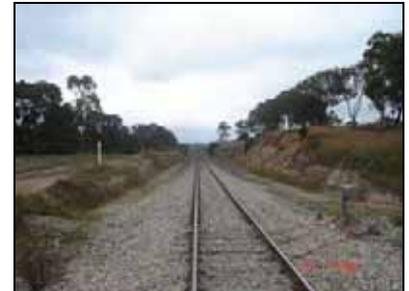
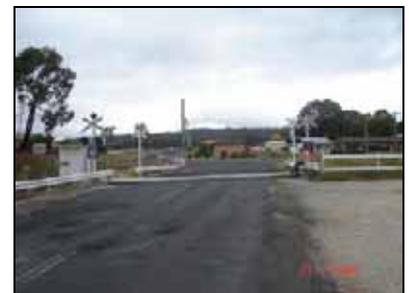
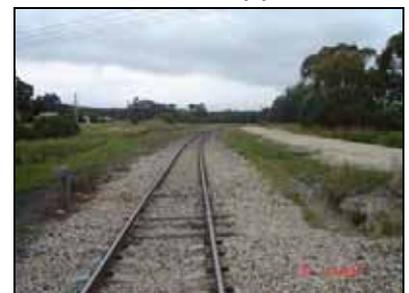
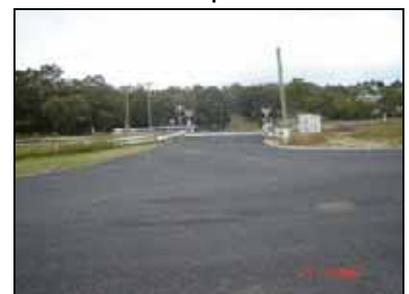
Mostly residential traffic.
Centreline and stop line road markings missing

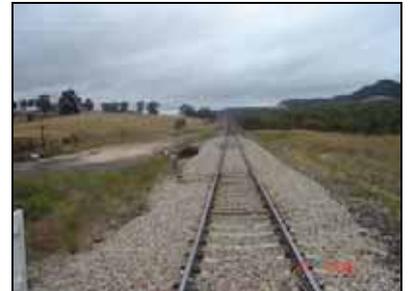
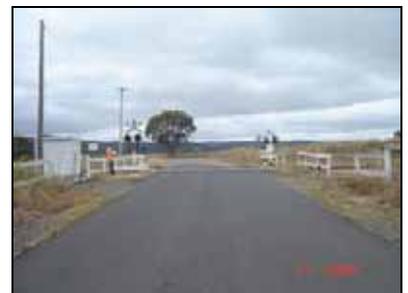
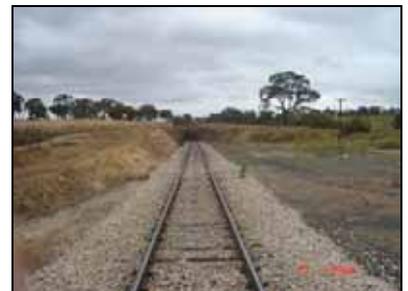
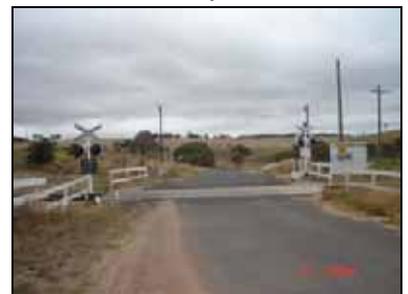
Line Wallerawang to Gulgong
 Crossing Name Cullen Bullen Km's from Sydney 188.233
 Road Name Location Cullen Bullen

Approach Surfacing Tarmac
 Crossing Surfacing Cast in situ concrete
 Protection Type Active
 Signage Stop on Red
 Type of Road Traffic Cars / Vans / Trucks
 Usage Medium
 Road Speed 35 kph
 Rail Speed 0 kph
 Rail Sighting Down End Medium
 Road Sighting Downside Poor
 Rail Sighting Up End Medium
 Road Sighting Upside Poor

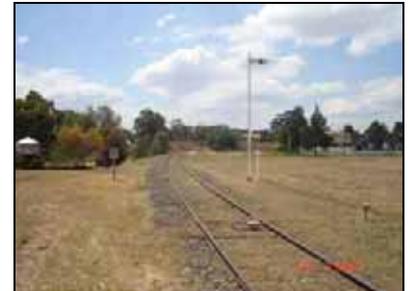
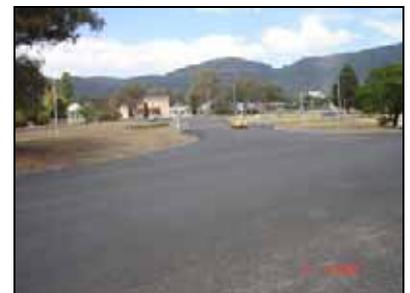
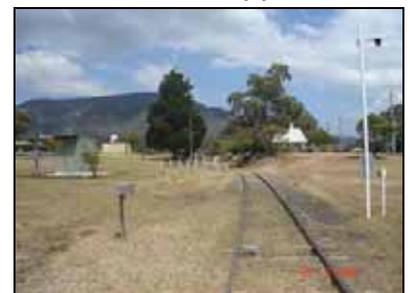
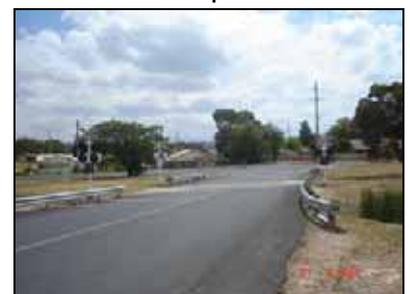
Very busy town centre crossing with side road on both approaches.
 Longer trains may cause delays during peak times eg School pickup/drop offs.
 This will be exacerbated by low line speed for rail traffic.

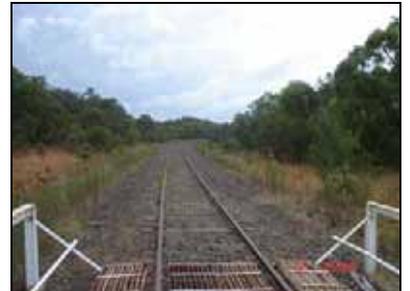
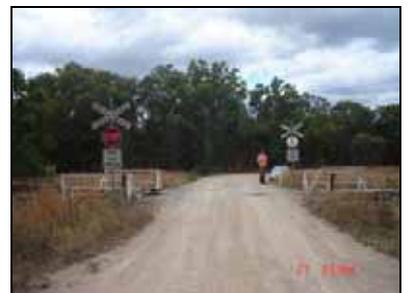
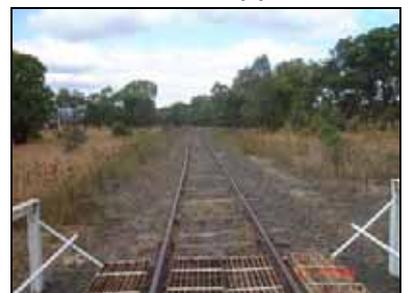
Line	Wallerawang to Gulgong		
Crossing Name	Public	Km's from Sydney	262.125
Road Name	Widles Lane	Location	Kandos

Approach Surfacing	Gravel
Crossing Surfacing	Gravel
Protection Type	Passive
Signage	Stop – Look For Trains
Type of Road Traffic	Cars / Vans / Farm Vehicles
Usage	Medium
Road Speed	20 kph
Rail Speed	0 kph
Rail Sighting Down End	Good
Road Sighting Downside	Medium
Rail Sighting Up End	Good
Road Sighting Upside	Medium

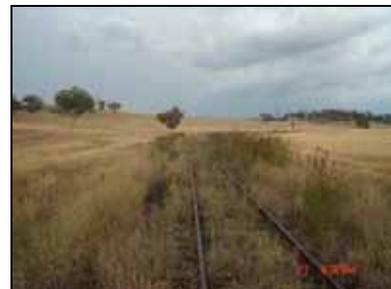
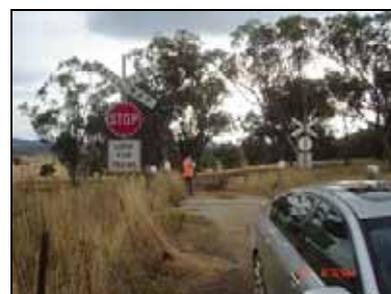
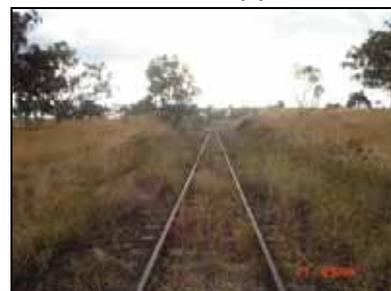
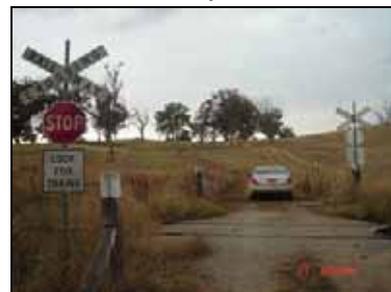
Crossing mostly for farm vehicles. Very low usage with poor condition approach roads

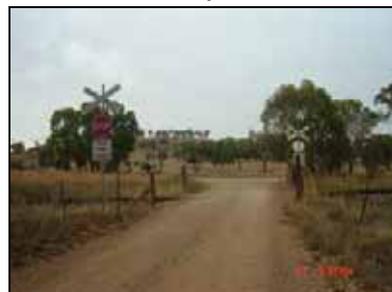
Up Side Approach

Line Wallerawang to Gulgong
 Crossing Name Lue Km's from Sydney 284.750
 Road Name Mudgee Road Location Lue

Approach Surfacing Tarmac
 Crossing Surfacing Tarmac
 Protection Type Passive
 Signage Stop – Look For Trains
 Type of Road Traffic Cars / Vans / Trucks
 Usage Medium
 Road Speed 60 kph
 Rail Speed 0 kph
 Rail Sighting Down End Poor
 Road Sighting Downside Poor
 Rail Sighting Up End Good
 Road Sighting Upside Good

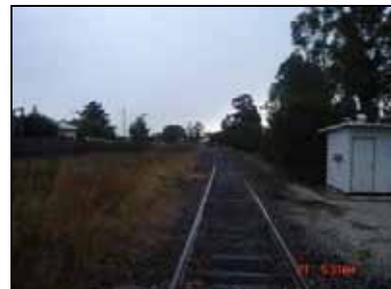
Down

Separate footpath crossing adjacent inc weave, inadequate signage and gravel surface

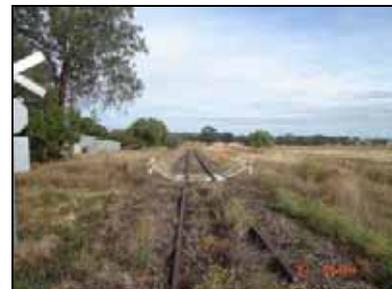
Line	Wallerawang to Gulgong		
Crossing Name	Public	Km's from Sydney	337.000
Road Name	Wonga Lee Lane	Location	Gulgong

Approach Surfacing	Dirt
Crossing Surfacing	Gravel
Protection Type	Passive
Signage	Stop – Look For Trains
Type of Road Traffic	Farm Vehicles / 4x4 only
Usage	Very Low
Road Speed	< 20 kph
Rail Speed	0 kph
Rail Sighting Down End	Good/Poor
Road Sighting Downside	Poor/Good
Rail Sighting Up End	Good
Road Sighting Upside	Good

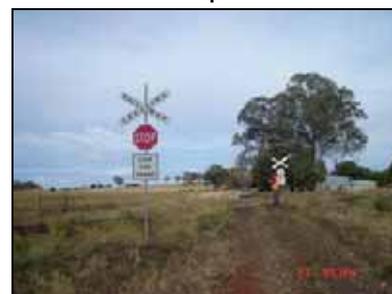
Rail Sighting Up End Poor

Road Sighting Upside Poor

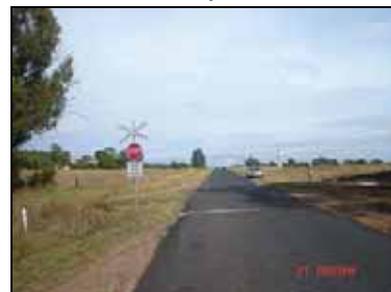
Rail Sighting Up End Medium/Good

Road Sighting Upside Good/Good

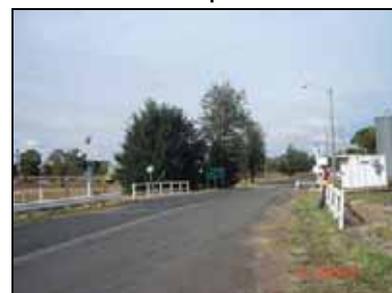
Rail Sighting Up End Good

Road Sighting Upside Good

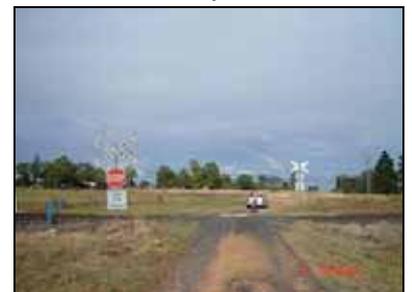
Rail Sighting Up End Good

Road Sighting Upside Good

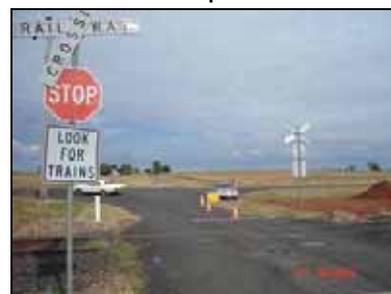
Rail Sighting Up End Poor

Road Sighting Upside Poor
