MOOLARBEN COAL PROJECT

Stage 2

European Heritage Assessment

European Heritage
Assessment of Identified
Items within Stage 2 of the
Moolarben Coal Project

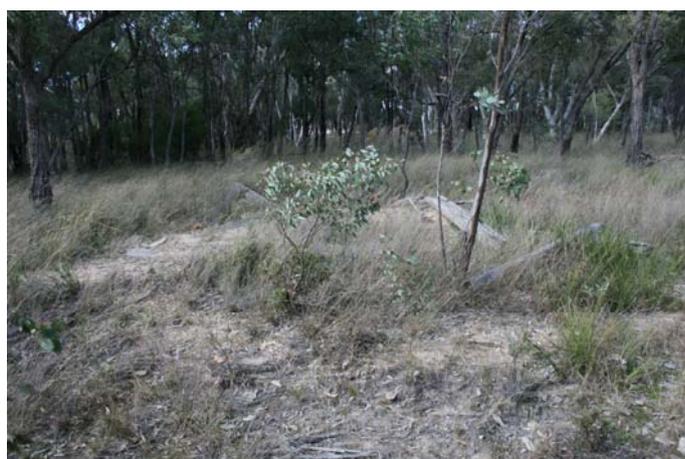
site name Murrugamba School Site

Sites of small bush schools are common in NSW, therefore this site is of importance to the local region. The site has been altered, but there is sufficient material remaining to provide information on the location of features such as school, toilets and water tank. Items such as bed logs, posts, tank, down-piping, bricks and plaster provide evidence of material used in construction. The undisturbed pit toilet has potential to provide further evidence of period of use from objects discarded. The evidence from the toilet may show that the building had other functions when not being used as a school, such as district hall or meeting place. It is considered that the site is significant in categories Criterion D and E of the NSW Heritage Office guidelines. Criterion D: Small bush schools were the focal point of an isolated rural community. In this case the school was built by the local residents with minimal financial assistance from the NSW Department of Education, and shows their determination to ensure their children received a rudimentary education. This was the only public building in the valley. Criterion E: The site has the potential to yield archaeological information and evidence of the culture that would not be available from other sites in this valley.

physical condition	The site is in a very poor condition.		
existing heritage listings	None.		
assessed significance	Local, with moderate value.		
impact status	High – within Open Cut 4.		
management recommendations	<ol style="list-style-type: none">1. Archival Record<ul style="list-style-type: none">- photographic- site plan to scale based on survey2. Archaeological Assessment

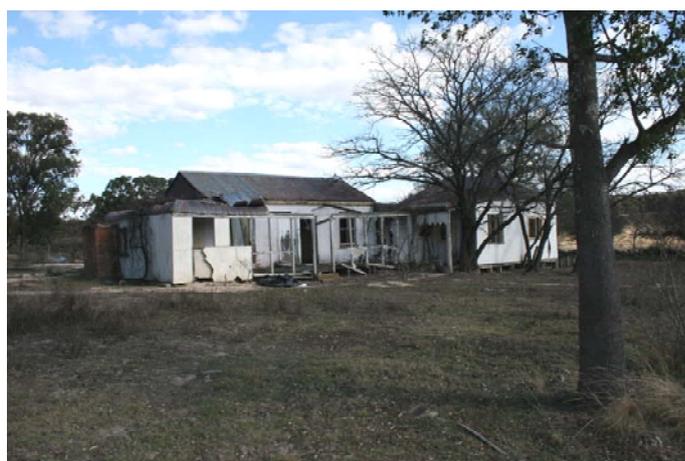
site name Farm Site

Homestead sites are common in NSW so this site is of local importance. It is of high importance as the site is reasonably intact and it is possible to see how the various buildings functioned and related to each other. The house has had a number of additions that have joined the living and kitchen areas together, but it is possible to determine the stages of construction. The house is constructed of hand-squared timber and undressed logs with sawn slab walls. Kitchen is of round timber and corrugated iron. Chimneys are constructed partly of brick in the base and corrugated iron top. There is an intact orchard, sheds, yards and saw bench. It is considered that the site is significant in categories Criterion C and E of the NSW Heritage Office guidelines. Criterion C: The building provides evidence of the technical ability of the original owner to construct a comfortable homestead using local material. It also shows that it was constructed on a limited budget. The method of construction is no longer practised. Criterion E: The site has the potential to yield archaeological evidence of diet and affluence. There is the opportunity to study the layout of homestead and other buildings to determine how the site functioned, as they are reasonably intact and this is not the case on many other homestead sites.

physical condition	The site has been unoccupied for some time and most of the buildings are in a poor condition.		
existing heritage listings	None.		
assessed significance	Local, of high value. There is high potential at this site to gain understanding of construction methods and the development of the farm.		
impact status	High – within Open Cut 4.		
management recommendations	<ol style="list-style-type: none">1. Historical Research2. Archival Record<ul style="list-style-type: none">- photographic- site plan to scale based on survey- measured drawing- identification and recording of landscape elements

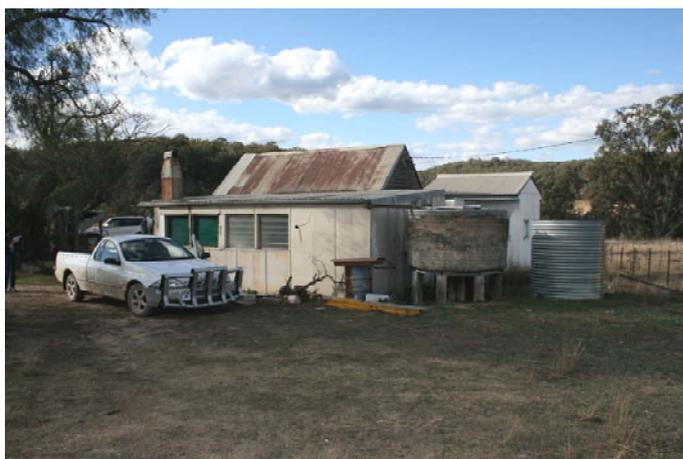
Homestead sites are common in NSW so this site is of local importance. It is of moderate value as some elements of the site have been modified and others have little heritage value, but as a whole is part of the significance of the site. The site retains the original vertical slab house along with a later fibro clad dwelling. The fibro dwelling was occupied at time of inspection and it was not possible to determine method of construction. The size and type of buildings provide evidence of the economic status of the owners.

site #	11 (sheet 2 of 2)		
site name	Farm Site		
property coordinate	GDA 55 H E0766030 N6423610	inspection date	30 June 2008
original owner	Thomas Carr	present owner	Ulan Coal Mines Pty Limited
history/description	<p>Selected by Thomas Carr as a Conditional Purchase block in 1883. By 1905 it was held by William Carr as a Conditional Purchase block and by 1933 he held it as freehold land.</p> <p>There are a number of buildings on the site including an early slab structure. The present house is clad in fibro, but was most likely slab also. There are a number of outbuildings including a shearing shed.</p>		
physical condition	The slab structure is in a poor condition, but the other buildings appear sound.		
existing heritage listings	None.		
assessed significance	Local, of moderate value.		
impact status	High – on boundary of Open Cut 4.		
management recommendations	<ol style="list-style-type: none">1. Historical Research2. Archival Record<ul style="list-style-type: none">- photographic- site plan to scale based on survey.3. Archaeological Assessment

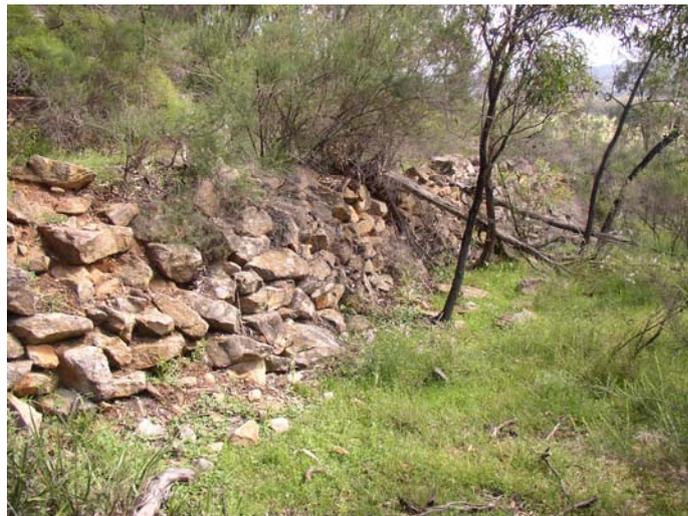
Stone retaining walls are common in NSW so this site is of local importance. It is of moderate value as the wall has suffered from neglect and intrusions of trees have altered the fabric. This road was an early communication link between Mudgee, Wollar and hence to the Hunter Valley. This road is known locally as the Maitland Road.

site #	18 (sheet 2 of 2)		
site name	Carr's Gap Road stone wall		
property coordinate	GDA 55 H E760776 N6422170	inspection date	not inspected
original owner	J W Robinson (part)	present owner	M & P Swords
history/description	<p>Part of the portion was taken up as a Conditional Lease by JW Robinson in 1905. Robinson converted this part to an Additional Conditional Purchase in 1945. The rest of the portion was declared available for selection in 1916, but was not taken up by 1948.</p> <p>The road was part of the Mudgee to Wollar Road that ran via Moolarben. The section over the range is called Carr's Gap and passes Murrugamba Trig point. The road is known locally as the Maitland Road. The section of interest is a dry stone wall supporting the road where it has been cut into the side of the hill.</p>		
physical condition	The wall is in a very good condition. ⁷		
existing heritage listings	None.		
assessed significance	Local, of moderate value.

impact status	High - on the boundary of Open Cut 4 and Underground 1.		
management recommendations	<ol style="list-style-type: none">1. Historical Research2. Archival Record<ul style="list-style-type: none">- photographic- site plan showing extent of wall

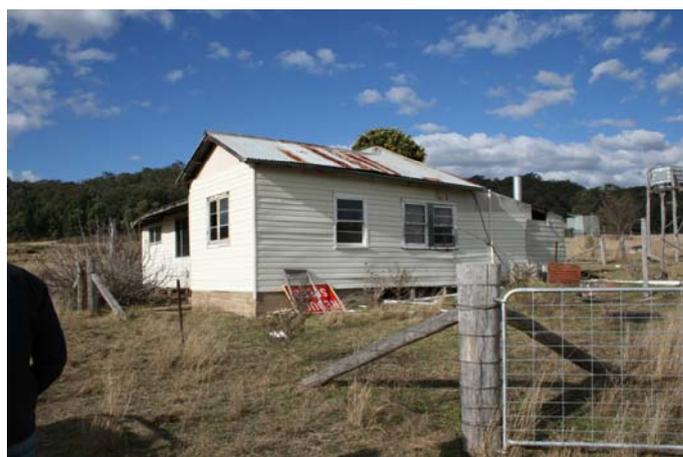
site name House Site

The original house was a small building with hip roof. Round bush timber was used for the roof structure. The building has had alterations and additions in a number of directions which has reduced its value and damaged its heritage significance. For these reasons it does not meet the criteria for listing at local level.

physical condition	The buildings are in a poor condition.		
existing heritage listings	None.		
assessed significance	Local, of intrusive value.		
impact status	High – on boundary of Open Cut 4.		
management recommendations	No further action required.

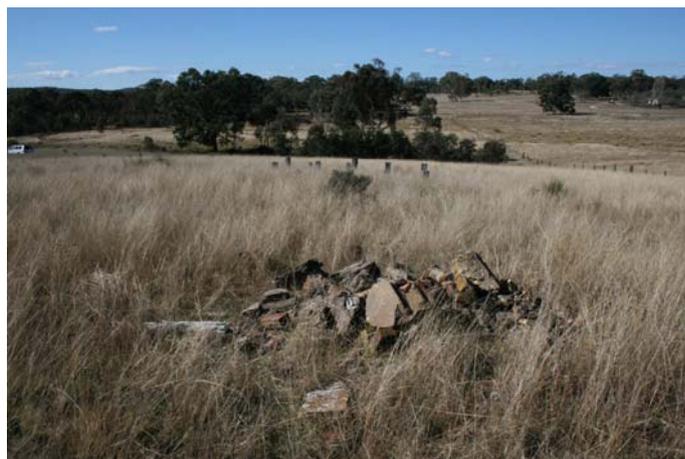
This area was taken up as a conditional purchase block in the 1880s. The only evidence of the homestead is the base of a fireplace, timber-lined well and orchard.

site #	36a (sheet 2 of 2)		
site name	House Site		
property coordinate	GDA 55 H E0763464 N6423520	inspection date	30 June 2008
original owner	George Carr	present owner	Ulan Coal Mines Pty Limited
history/description	Selected by George Carr in 1883 as a Conditional Purchase block, by 1905 it was held by HS Thomas. Site contains a well, stone base of a fireplace, partly dressed timber, and exotic trees (white cedar, pear and figs). The site is associated with Site 36b.		
physical condition	Very little remains on the site of the building, but the area does not appear to be disturbed.		
existing heritage listings	None.		
assessed significance	Local, of high value.		
impact status	High - on the boundary of Underground 1 and Open Cut 4.		
management recommendations	<ol style="list-style-type: none">1. Historical Research2. Archival Record<ul style="list-style-type: none">- photographic- site plan to scale based on survey- identification and recording of landscape elements

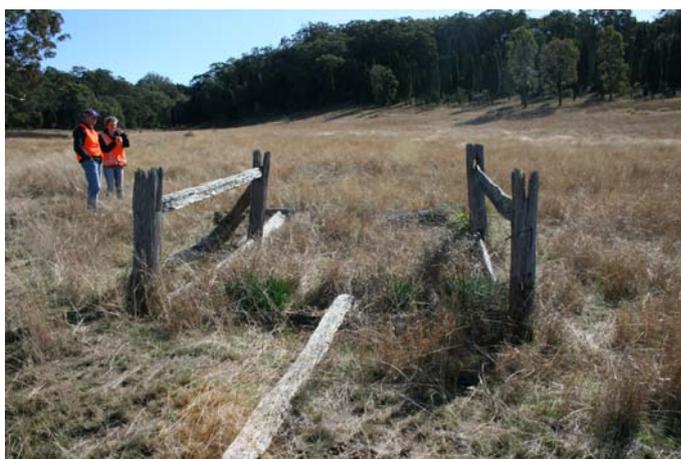
Homestead sites and rural burials outside of designated cemeteries are common in NSW so this site is of local importance. This area was taken up as a conditional purchase block in the 1880s. The burial site is approximately 180 metres east of the house site (see item #36a). The fence had been constructed as a square with squared posts and mortised rails. At some stage the area was extended with round posts. It appears to mark two burials. At the time of inspection bulbs were growing in the enclosed area, though the species could not be identified.

site #	36b (sheet 2 of 2)		
site name	Grave Site		
property coordinate	GDA 55 H E0763464 N6423520	inspection date	30 June 2008
original owner	George Carr	present owner	Ulan Coal Mines Pty Limited
history/description	Selected by George Carr in 1883 as a Conditional Purchase block, by 1905 it was held by HS Thomas. Site contains an enclosed area that appears to be a grave or burial site. The enclosure is approximately 2.5m x 5m defined by timber posts and rails, and wire. It appears that the area was extended to the west at some stage. There are bulbs growing at the east end of the enclosure. The site is associated with Site 36a.		
physical condition	In reasonable condition though two posts have rotted off.		
existing heritage listings	None.		
assessed significance	Local, of high value.		
impact status	High - on the boundary of Underground 1 and Open Cut 4.		
management recommendations	<ol style="list-style-type: none">1. Historical Research2. Archival Record<ul style="list-style-type: none">- photographic- site plan to scale based on survey- identification and recording of landscape elements3. Archaeological Assessment<ul style="list-style-type: none">- assessment of grave site, with scope to be confirmed by archaeologist specialising in cemeteries and burials- management plan for grave & burial, including possible ex situ conservation

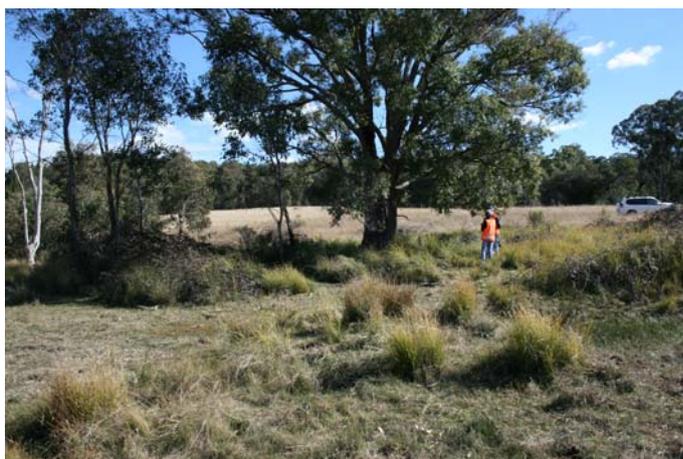
site name House Site

Abandoned homestead sites are common in NSW, so this site is of local importance. This area was another conditional purchase selection from the 1880s. It may have had up to four structures in the area as surface deposits indicate the base of chimneys. The last structure may have had a septic system. Criterion E: The building sites have potential to yield new archaeological information on construction methods, date of construction and possible use of the building. This will provide information on the dynamics of the site and identify the group who occupied the site in a local context. Due to most of the surface material having been removed it is considered to have moderate local value, though its archaeological value would be high.

management recommendations	<ol style="list-style-type: none">1. Historical Research2. Archival Record<ul style="list-style-type: none">- photographic- site plan to scale based on survey- identification and recording of landscape elements

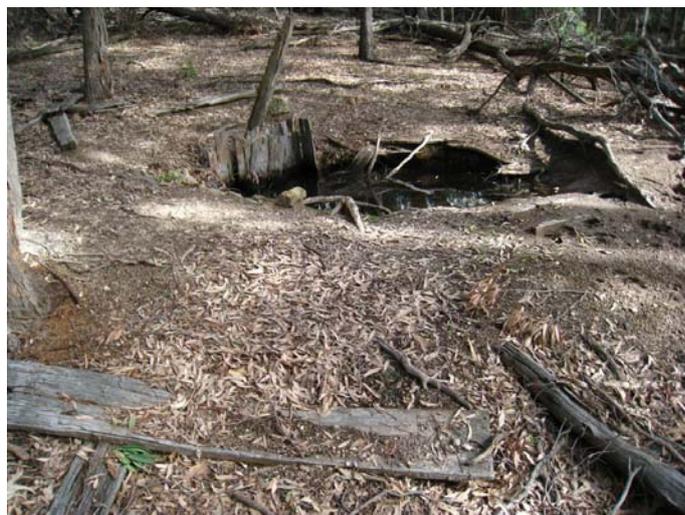
Although the history of this apparent water trough and spring fed well is unknown, it is a common feature on rural properties in the area. With reference to the NSW Dept of Planning, Heritage Branch guidelines for assessment of heritage items, this item satisfies Criterion E: *an item has the potential to yield information that will contribute to an understanding of the area's cultural or natural history*. The item is currently located on the boundary of the Munghorn Gap Nature Reserve.

site #	55 (sheet 2 of 2)		
site name	Water Trough and Spring Fed Well		
property coordinate	GDA 55 H E765442 N6417706, 560m Elevation	inspection date	23 July 2008 (by Wells Environmental Services)
original owner	John Berryman first owner in 1888, circa 1917 owned by HJ Gudgeon, F Tomlinson and LC Naughton. Unknown who constructed.	present owner	Moolarben Coal Mines Pty Limited
history/description	History unknown. The site includes a 6ft x 6ft timber lined well, which delivers water via a metal trough to a hollowed timber log water trough. Deteriorated cementitious material in the base suggests the trough was previously lined. The metal trough is supported by timber posts. One side of the well is sandstone conglomerate, and the pit is at least 5ft deep.		
physical condition	Appears to be poor.		
existing heritage listings	None.		
assessed significance	Local, of high value.		
impact status	Low/nil - outside area of perceived impact. Possible indirect impact by draining of water.

management recommendations	1. Archival Record - photographic only 2. In situ Conservation

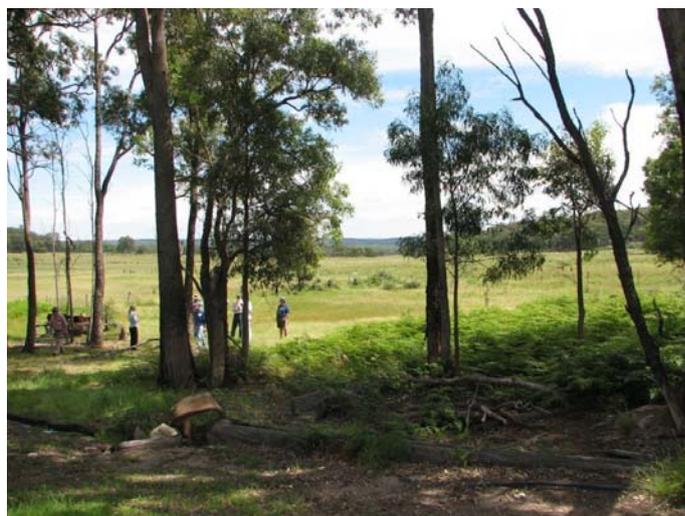
Although the history of this apparent water trough and spring fed well is unknown, it is a common feature on rural properties in the area. With reference to the NSW Dept of Planning, Heritage Branch guidelines for assessment of heritage items, this item satisfies Criterion E: *an item has the potential to yield information that will contribute to an understanding of the area's cultural or natural history.* The item is currently located on private land near the boundary of the Munghorn Gap Nature Reserve.

site #	56 (sheet 2 of 2)		
site name	Water Trough and Spring Fed Well		
property coordinate	GDA 55 H E766203 N6419606 476mAHD Elevation	inspection date	28 Nov 2007 (by Wells Environmental Services)
original owner	Site appears to have originally been a Classification Reserve. Has been noted as early as 1905 as a watering location or spring, later owned by William Robinson or OJ Power & PH Powers. Constructed by unknown.	present owner	E.D & C Power
history/description	Appears to have been watering location for early stock driving. The site includes a well, the opening of which is covered over with sheets of corrugated metal. October 2007 photos appear to indicate the well is sandstone lined. The well delivers water to a series of timber troughs.		
physical condition	Appears to be fair.		
existing heritage listings	None.		
assessed significance	Local, of high value.		
impact status	Low/nil - outside area of perceived impact. Possible indirect impact by draining of water.

management recommendations	1. Archival Record - photographic only 2. In situ Conservation

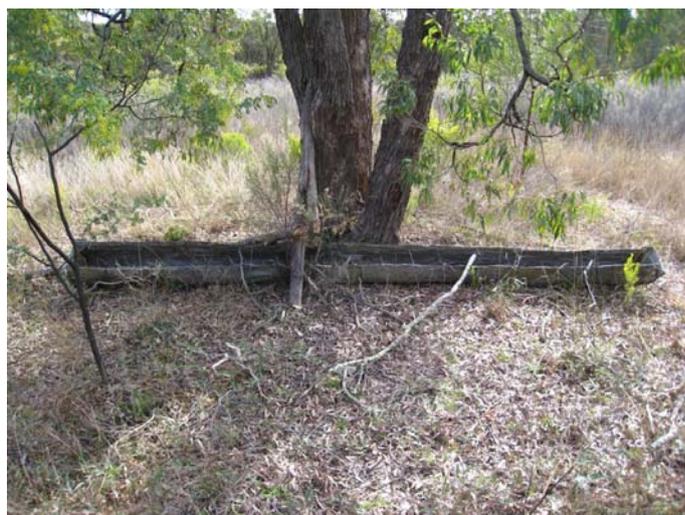
The history of this apparent feed trough is unknown. However, with reference to the NSW Dept of Planning, Heritage Branch guidelines for assessment of heritage items, this item satisfies Criterion E: *an item has the potential to yield information that will contribute to an understanding of the area's cultural or natural history.*

site #	57 (sheet 2 of 2)		
site name	Feed Trough		
property coordinate	GDA 55 H E763180 N6426332	inspection date	23 July 2008 (by Wells Environmental Services)
original owner	Circa 1924 Alex Campbell(?), later owned by railway authorities. Constructed by unknown.	present owner	Ulan Coal Mines Pty Limited
history/description	History unknown. A hollowed timber log used as a feed or water trough.		
physical condition	Appears to be fair.		
existing heritage listings	None.		
assessed significance	Local, of moderate value. The unknown history of the item means it may have been moved from another site.		
impact status	High - adjacent to proposed road alignments.		
management recommendations	<ol style="list-style-type: none">1. Archival Record - photographic only2. Ex situ Conservation (if not impacted, in situ conservation)

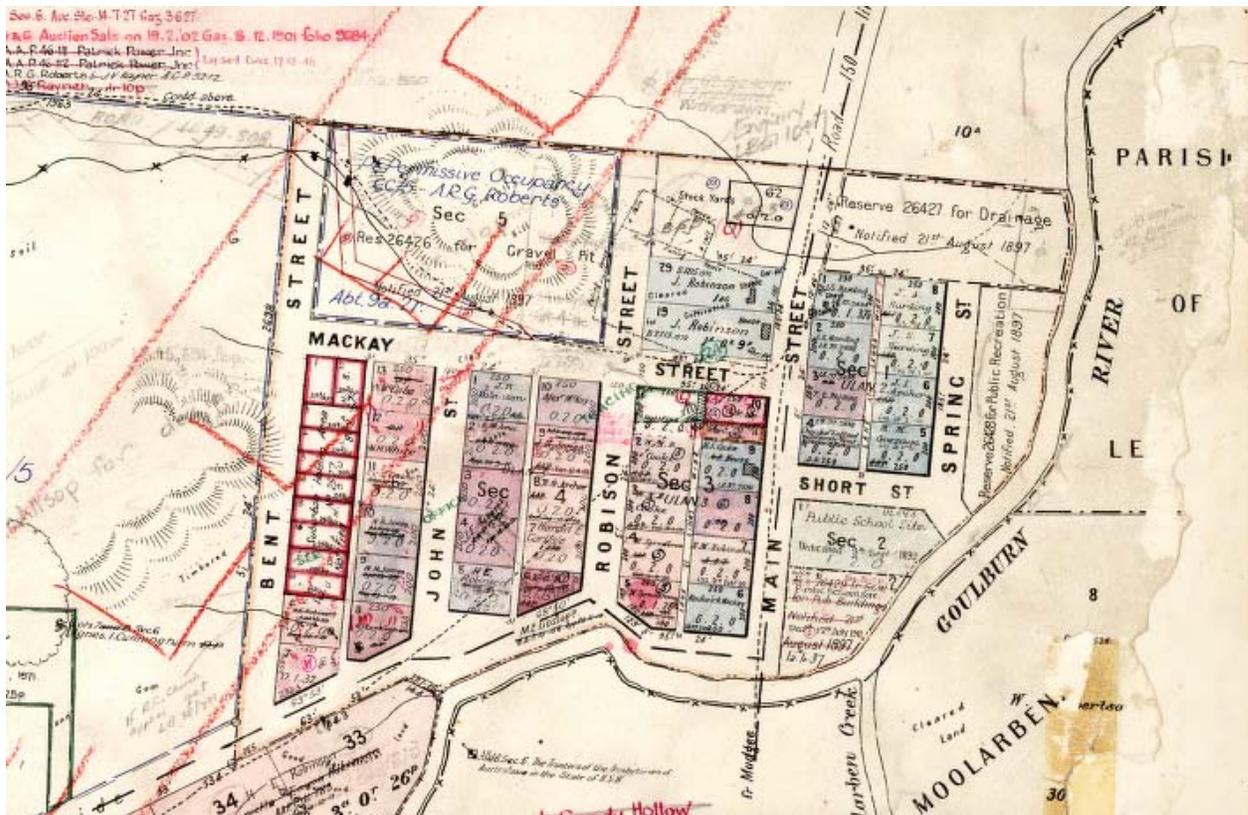
Figure 7. Plan for the Village of Ulan 1st Edition 1898²⁷

There was only one village to develop within the study area and that was reasonably late. The village of Ulan was proclaimed 21 August 1897 on the west bank of the Goulburn River where Moolarben Creek joins it. It was set out as a small village with four sections of residential land and never progressed beyond that. See Figure 7, which shows the layout of the village. In 1908, the Ulan Post Office was reported as serving a district of 35 families with a total population of 196 persons. In 1912 it was reported that Ulan had a hotel/store, three boarding houses, 23 householders and 20 other persons²⁵ In 1914 the village had hotel, post office, hall, church, school and eight houses.²⁶ There were some periods of growth such as when the power station and associated mine opened, but many of the workers came from the surrounding small farms. The village has had a store, post office, butcher shop, garage and hotel; at present only the hotel remains. See Appendix 2 for reminiscences about the village.
