UG4 Longwalls 401 to 408 Extraction Plan

Surface Water Technical Report

Moolarben Coal Operations Pty Ltd
0926-40-B5, 2 November 2021

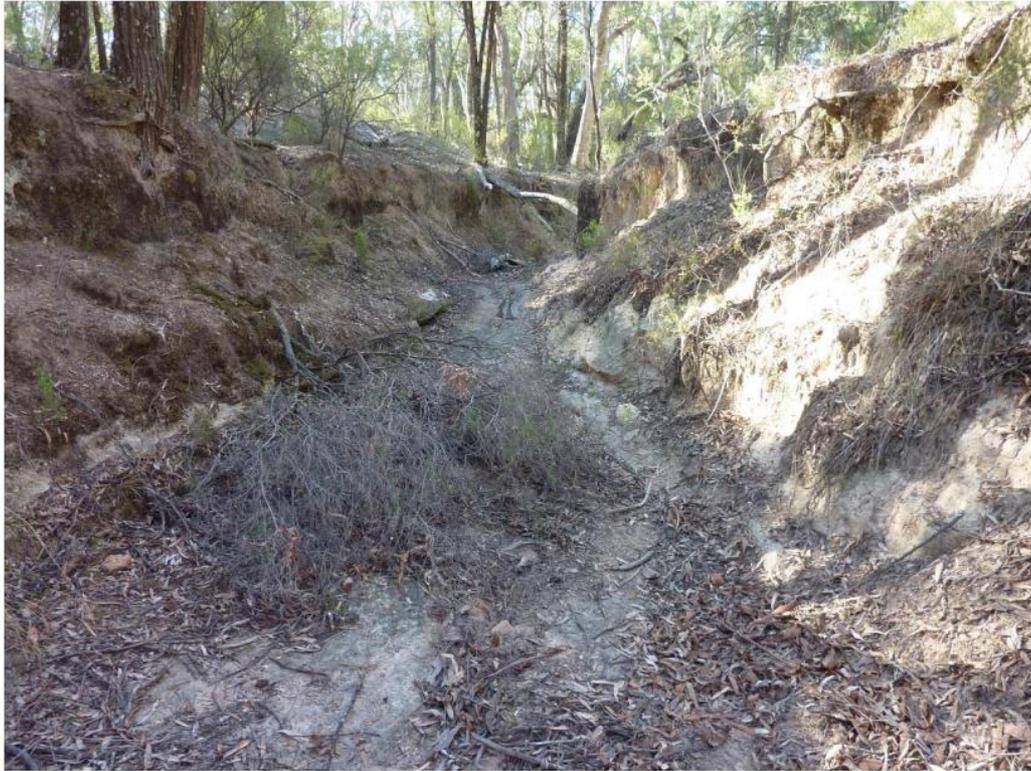
Figure 2.3 - Photographs showing Drainage Line 2 (Source: MSEC, 2021)

The MSEC (2021) report noted that the drainage lines within the Study Area comprise a rounded gravel to sandy and silty base. There is also debris along sections of the streams, including boulders, tree branches and other vegetation. The valley profiles of the drainage lines are predominantly broad and shallow with some incised sections as shown in Figure 2.3.
